PFE HOSE

PRESSURE FEEDBACK EGR HOSE

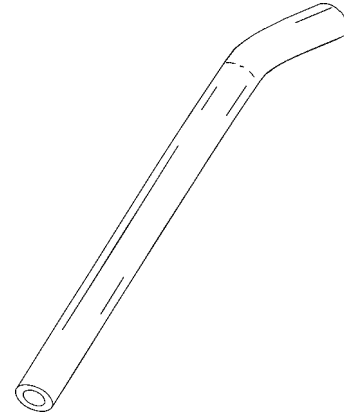
FIG. 1

May need to be cut to fit.

OEM#	PART#	PART#	APPLICATION & YEAR	FIG#
	FORD			
E83Z-9P761B	10899	10899*	FORD 86-95, F TRK 86-94, LINC 88-93, MERC 86-95	1
