KLEAN SCREEN™

EGR Valve Gaskets with Integrated Carbon Filters

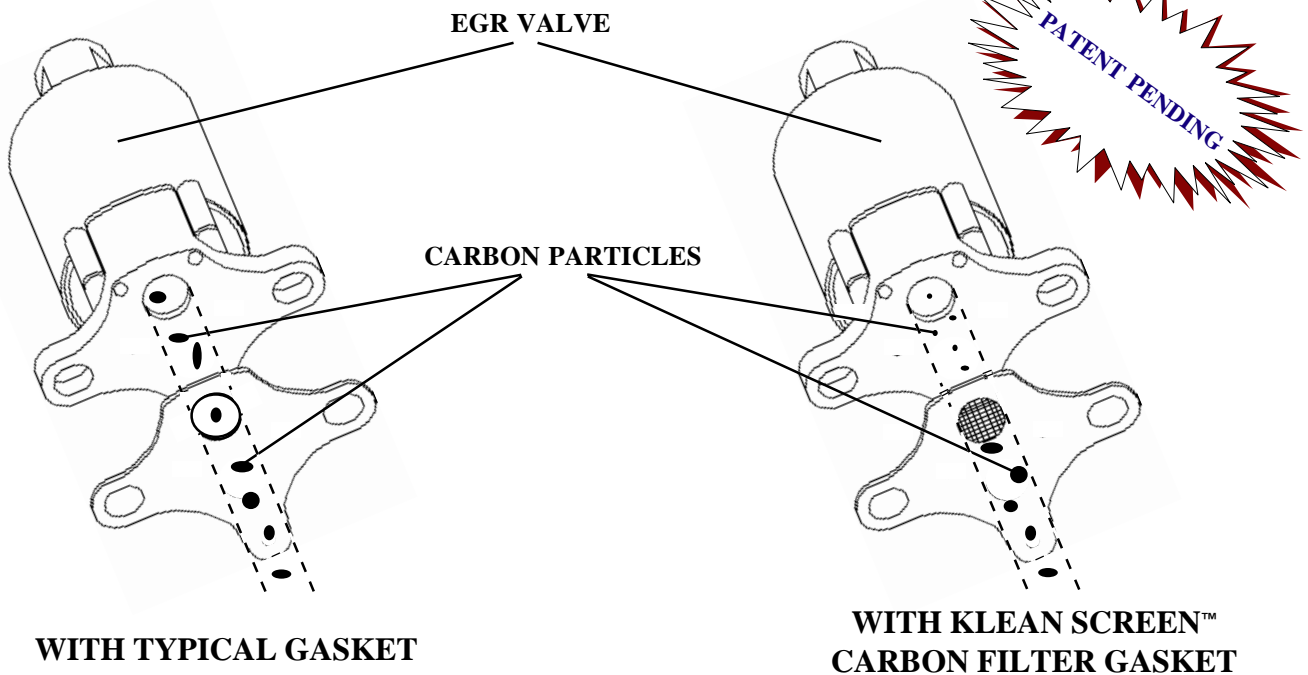
SOLUTION : TOMCO, Inc. has developed **KLEAN SCREEN™ TECHNOLOGY** that actually *prevents* EGR Valves from fouling. The KLEAN SCREEN™ GASKET takes the place of the original equipment type gasket. The integrated carbon filter screen covers the hole where the exhaust gas enters. These heat resistant, stainless steel screens catch the carbon particles before they can cause trouble inside the EGR Valve. As heat is built up around the screen, these larger particles are burnt off or dissipated into smaller, non-clogging particles.

PROBLEM : Every technician has experienced the frustrating situation with EGR Valves that are prone to carbon clogging. This carbon buildup can cause the EGR pintle to stick open or closed. The result can be rough idling, stalling, hesitations, surging, pinging, malfunction indicator lamps (MIL) to be set and / or failed emissions tests. Even a new EGR Valve may very well foul again in a very short period of time.
